Last Modified: 6-2-2008	5.1 C	From: 200601
Model Year: 2007	Model: Camry	Doc ID: RM000000PDV012X
Title: 2GR-FE ENGINE CONTROL SYSTEM: SFI SYSTEM: P0016: Crankshaft Position - Camshaft Position Correlation (Bank 1 Sensor A) (2007 Camry)

DTC	P0016	Crankshaft Position - Camshaft Position Correlation (Bank 1 Sensor A)
------------	--------------	--

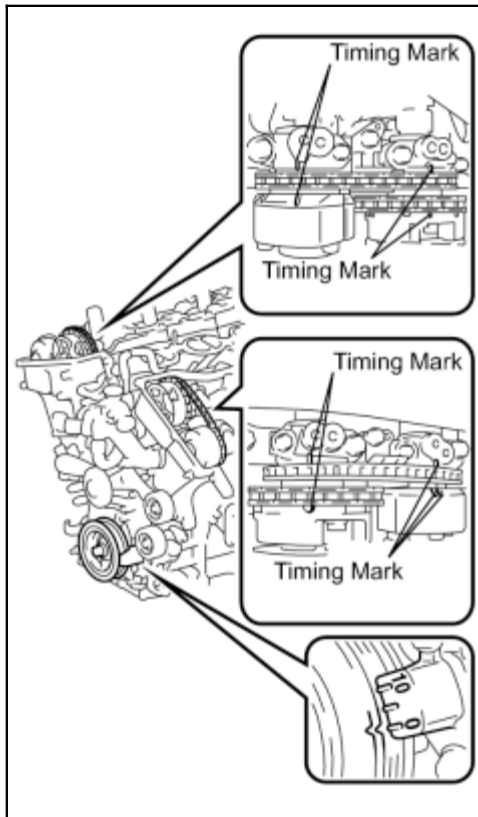
1.	CHECK VALVE TIMING (CHECK FOR LOOSE AND A JUMPED TOOTH OF TIMING CHAIN)
-----------	--

(a) Remove the cylinder head covers RH and LH.

(b) Turn the crankshaft pulley, and align its groove with the timing mark "0" of the timing chain cover.
